## Challenge

A waste management plant in Sweden runs a heavy-duty centrifugal pump to process its slurry. Despite installing a robust mechanical seal, the pump's reliability was not satisfactory. The seal failed.

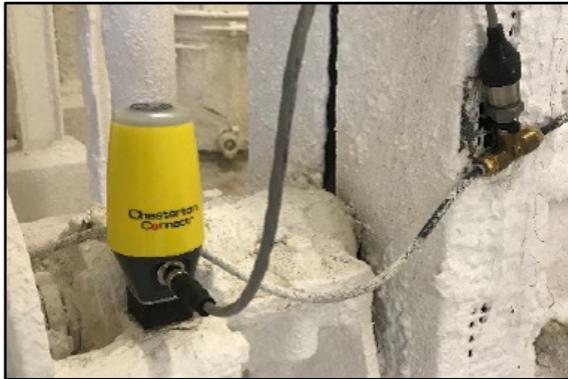
Chesterton Connect attached to slurry pump.

The Chesterton Connect was set to monitor the seal 24/7 and revealed during the night shift, when switching off between pumps the operator often forgot to switch on the flush water/barrier water.

Based on these findings, the staff was able to make corrections to the work schedule, increasing overall reliability. The pump is running successfully without failures.

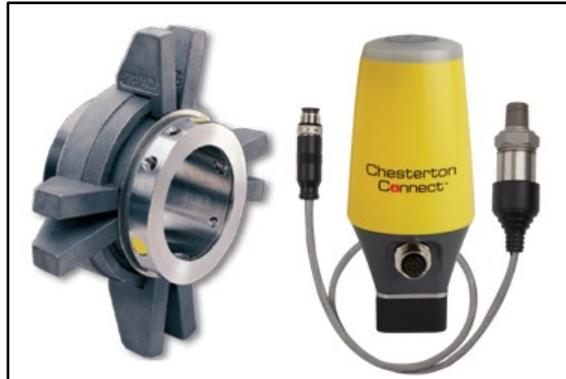
Chesterton 155 Seal with SprialTrac and Chesterton Connect.

The local Chesterton representative recommended a **Chesterton Connect™** sensor, a retrofitted **Chesterton 155 Mechanical Cartridge Seal 45 mm size**, and further protected by a **SpiralTrac** active throat bushing.

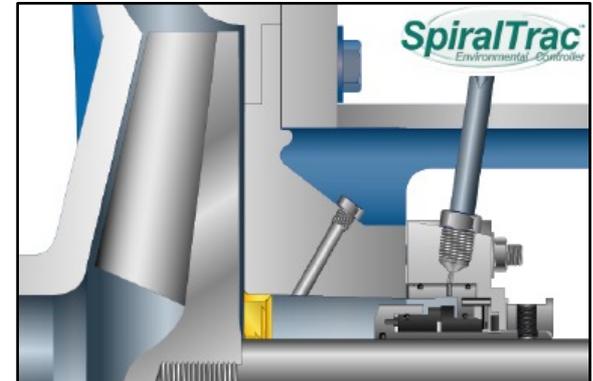
API Plan 32 flush.
