## 442 and SpiralTrac Performing "Far Beyond We Could Ever Imagine" part 2

Hydropower | River water | Mechanical Seal

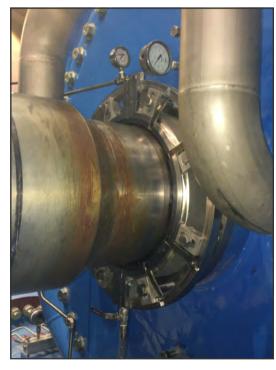
Chesterton solution installed, no leakage, downtime eliminated

- Chesterton 442 split seal 425 mm RSC/RSC/FKM SS
- SpiralTrac Version F Type S made of carbon graphite PTFE (ESC) material, dwg #17-0010
- Adapter plate

Chesterton solution was installed in a Plan 13 suction recirculation setup without any start up leakage. Some of these solutions have been running for over 5 years without leakage, eliminating all downtime!
