Health & Safety Improvements around Vertical Hydro Pulper with 442C and SpiralTrac

Pulp & Paper | Pulp | Mechanical Seal

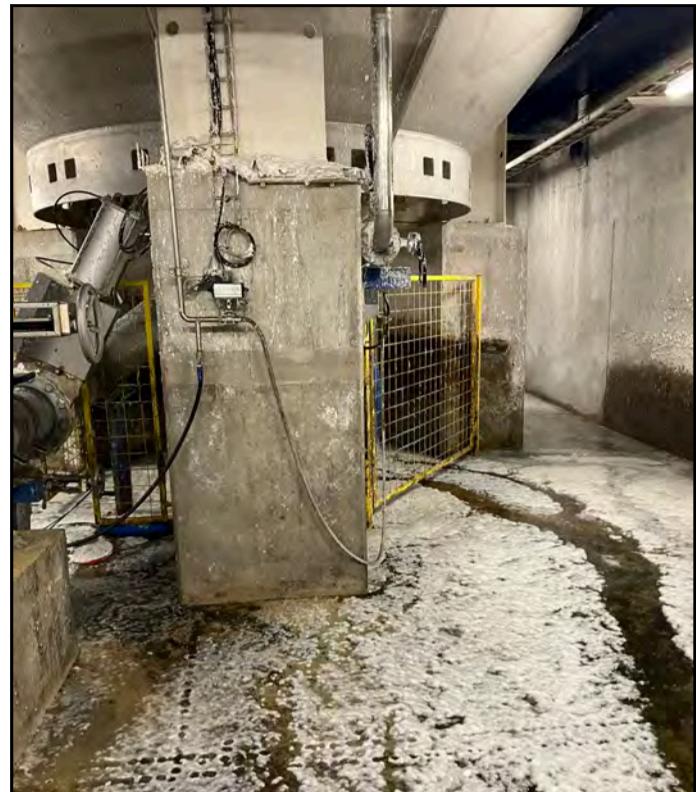
Originally packed application. Newly installed packing started leaking water after 3 days and started excessively leaking water and product after **7 days!** Equipment was turned off only once a month during production shut down, so the leaking product kept accumulating on the floor. This leaked water and paper stock promoted algae growth, which made the floor extremely slippery, almost impossible to walk on. As a result, the equipment was very hard to access for any maintenance and inspection.

Hazardous conditions caused by excessive leakage

- Chesterton 442C SA 160mm RSC/RSC S FKM
- Split SpiralTrac Version F Type S** part# FM16000RS19000(ESC)
- Chesterton Connect™ Process Monitoring System

Since installation, the floor is dry (no more algae growth), not slippery, health and safety around equipment has **massively increased**, housekeeping costs lowered.

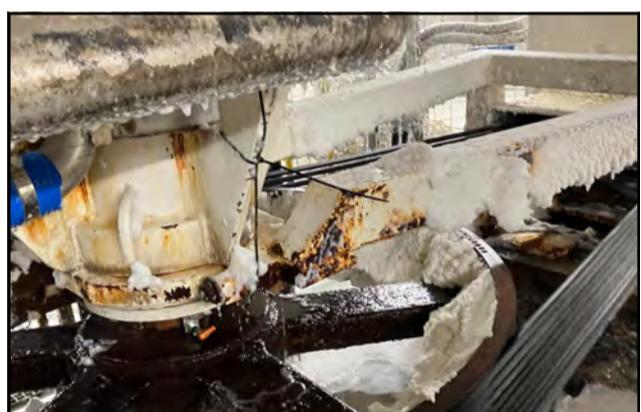
Excessive product leakage after 7 days of repacking

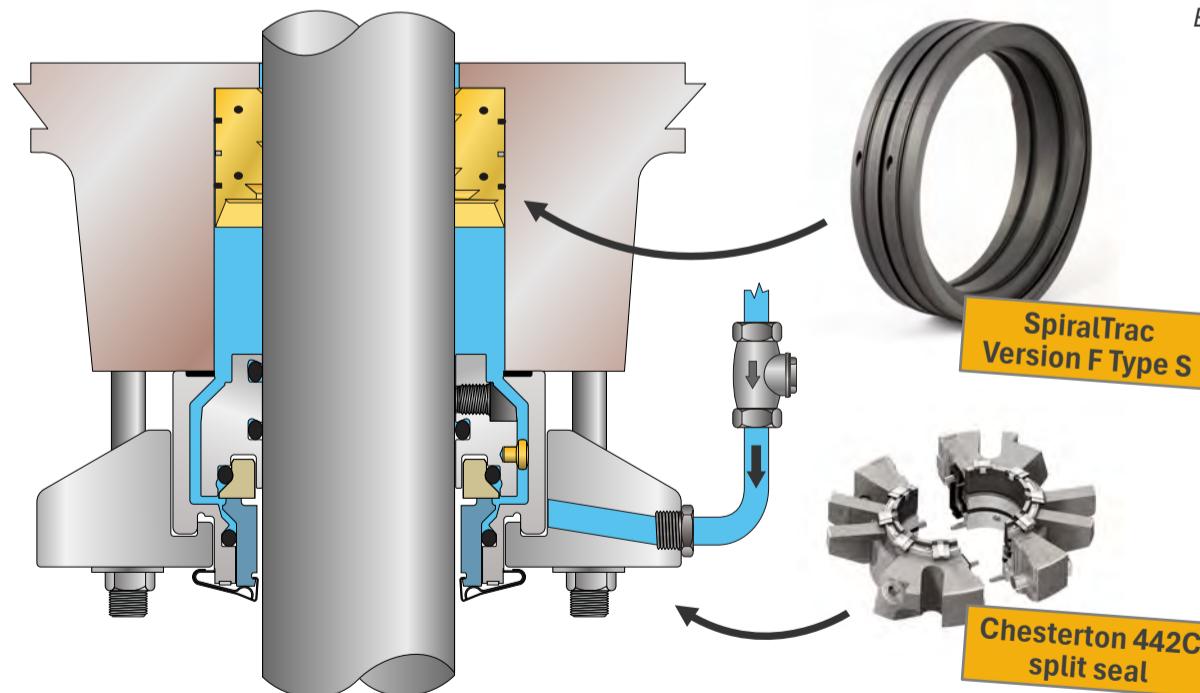
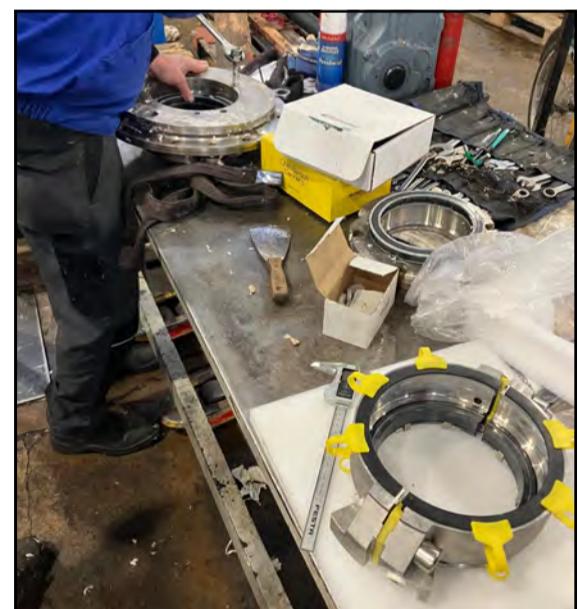
Chesterton solution being installed
