Application Success Story:

Industry: Pulp & Paper Product: Paper Stock

Sealing Solution: Mechanical Seal

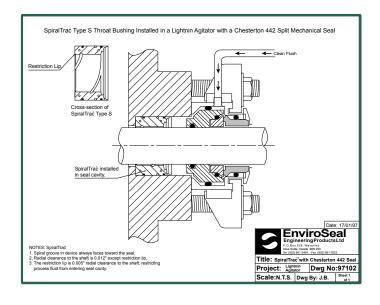
- Excessive flush and leakage with conventional packing
- Poor packing life, 3 to 6 months
- Severe sleeve wear
- High maintenance costs

- SpiralTrac[™]Version F
 Type S installed with a 442 split mechanical seal
- Greatly reduced flush rate
 8-10 GPH / 30-49 LPH
 and no leakage
- Dramatically increased MTBR
- Dramatically decreased operating and maintenance costs
- Customer very happy
