# **Application Success Story:**

Industry: Pulp & Paper

Product: Pulp Sealing Solution: Packing

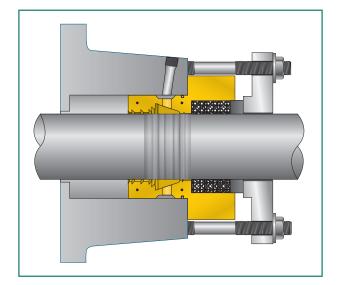
- Lightnin Mixer

- Shaft worn badly
- Excessive Flush
- Excessive Product Leakage
- \$8000.00 to replace shaft
  and bearings plus downtime costs

SpiralTrac<sup>™</sup> Seal Adaptor designed to move the packing to an area of the shaft with less wear and 3 rings of Chesterton high quality packing

- Doubled the life of the shaft
  at only 1/8 of the cost of a new one
- Now only Clean Leakage at the gland
