Application Success Story:

Industry: **Corn Processing**

Product: **Tank Bottoms**

Sealing Solution: **Mechanical Seal**

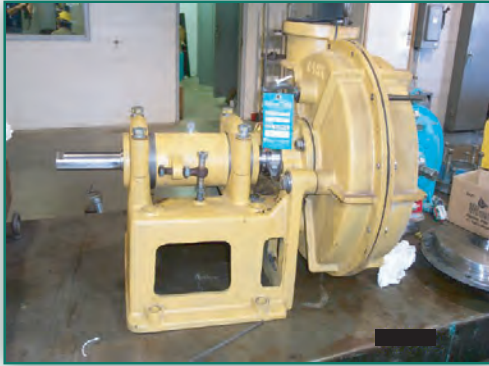
- Lightnin Ceramic lined pump
- RPM: 1750
- Tank Bottoms (Carbon, Diatomaceous Earth, Corn Syrup, water)
- Solids : 8-15%
- Temp: 70 - 90°F / 21 - 32°C
- Shaft size: 1.875" / 47.63 mm

- Previously the seal was lasting only six months
- The failure was mainly due to erosion of the stuffing box to seal mounting surface
- Approximate cost of repairs \$4425.00 per failure

- SpiralTrac Part# NI1875RI2750 (416) Stainless Steel was installed along with a Chesterton 155 SSC/TC, AFLAS.

- With a failure rate of 6 months they have avoided 3 failures to-date. Assuming the same cost of repair, the savings to date are \$13,275
