Application Success Story:

Industry: Pulp & Paper

Sealing Solution: Mechanical Seal

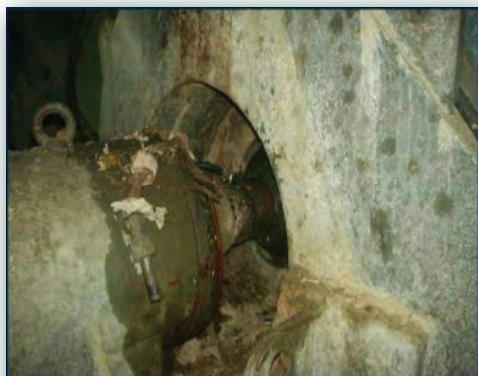
- Valmet S-0338 Horizontal Pulper
- Shaft: " / 100 mm
- Bore: " / 230 mm
- Product: Paper Stock

- The stuffing box was originally designed for gland packing and was upgraded to a John Crane single non-split seal.
- Even as the pulper started to leak the customer accepted the leakage, because of the required repair time and activity, which could cause 12-20 hrs out of production.

- SpiralTrac™ Seal Adaptor AFN8129R (316)
- Chesterton 442 Split Seal with RSC/RSC-EP configuration
