Application Success Story

Petrochemical • Crude Oil Upstream • Seal

Easily Manage Your Tough Operating Conditions with SpiralTrac™

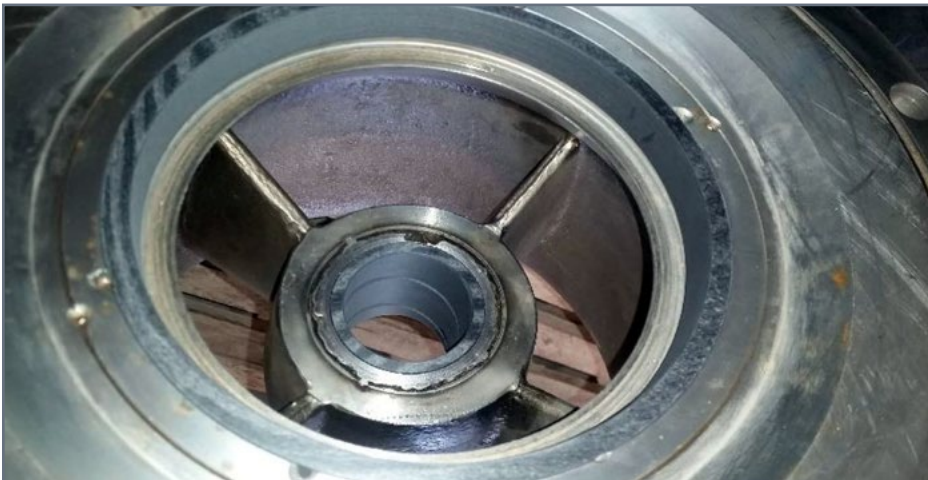
SpiralTrac press fit installation shown from the impeller side

Chesterton 225A Heavy Duty Industrial Dual Seal replacing OEM Seal. SpiralTrac Version N Type I installed for cleaning the stuffing box, providing a clean environment for the seal. Utilizing Plan 13.

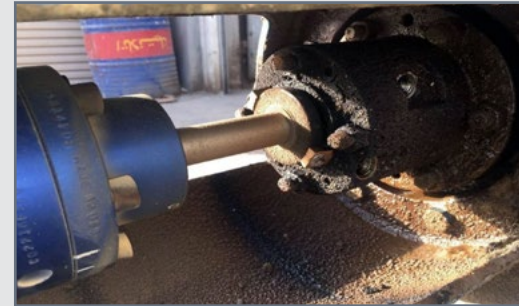
Aggressive operating conditions

Aggressive operating conditions (waste oily salt water associated with high percentage sand particles, H2S and chloride). Pump failure every 3-4 months due to aggressive sand particles and oily water, resulting in bearing/shaft sleeves worn out and lead to high vibration and mechanical seal leakage. High cavitation causing unstable axial movement. High maintenance costs.

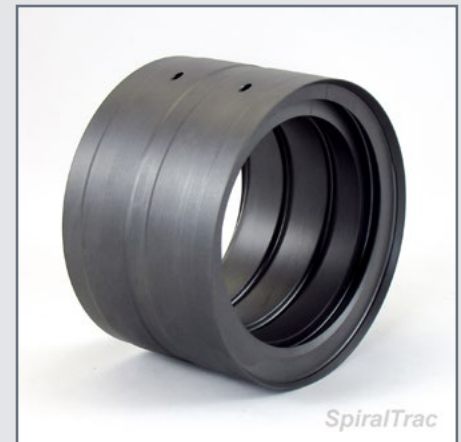
Seal Version SpiralTrac made of BGE material

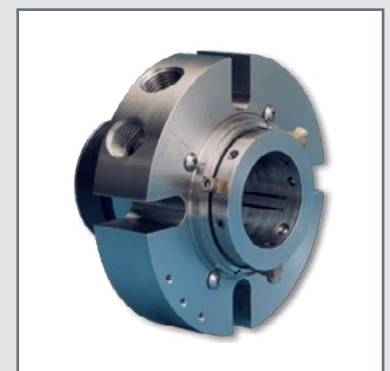
Chesterton 225A™ Heavy Duty Dual Seal
